Manhole Inspection Summary

Manhole # S45C2_020MH

Insp Date: **12/19/07 9:17 AM**

Location Address: **1324 Pontiac Ave**

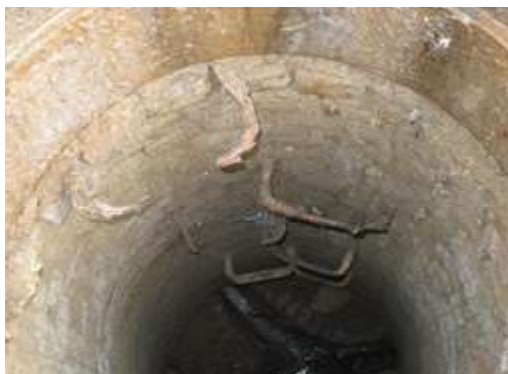
Steps Count: **6** Missing: **3** ☒ Corroded

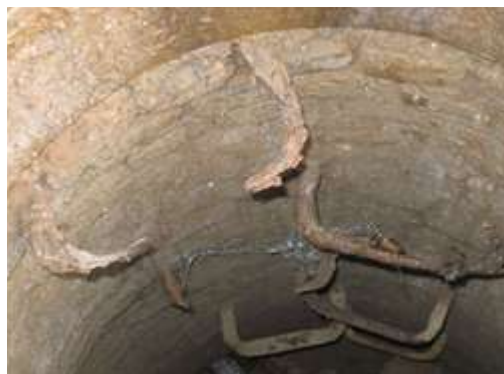
Defect 2

Missing/corroded steps

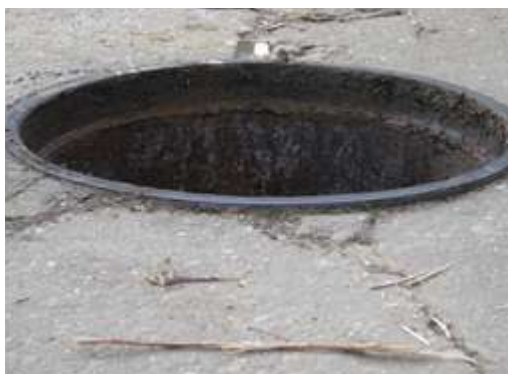
Defect 1

Above grade

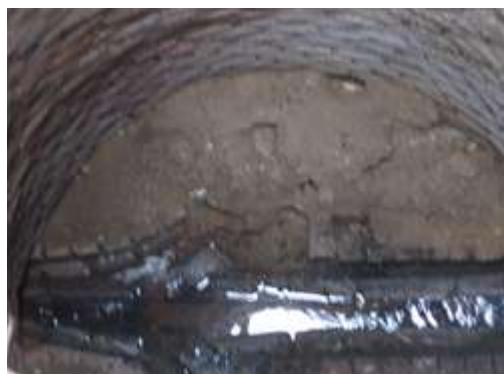
Defect 3

Condition: ☐ Sound ☐ Cracked ☐ Root Intrusion ☐ Deteriorated ☐ Leaks ☒ Debris

Debris completely covering channel opening and pipe

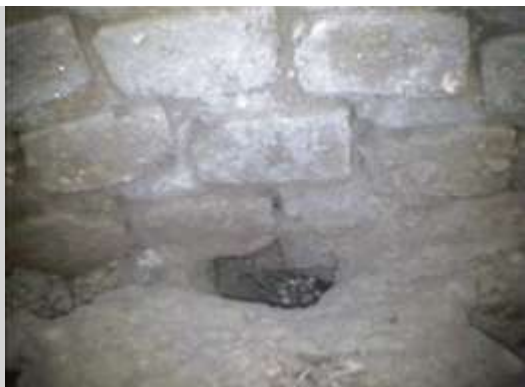
3 O'Clock Inflow

Comments **Measurements for influent pipe @ 3 O'clock unobtainable due to excessive debris.**

Pipe Height: **3.6** (in.) Rod and Bar (Angled)
Pipe Material: **Clay** ☐ Pipe Lined
Invert Depth: (ft.) Flow Characteristics: **None**
Deposits: ☐ None ☒ **Mud** ☐ Sludge ☒ **Debris** ☐ Grease
Silt Depth: **4** (in.) Deposits Extent: **Heavy**
Infiltration: **None** Pipe Seal Cond: **Unknown**

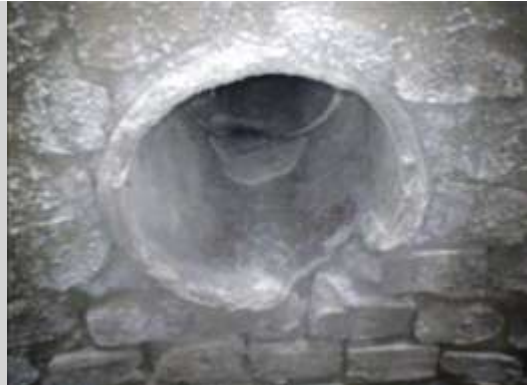
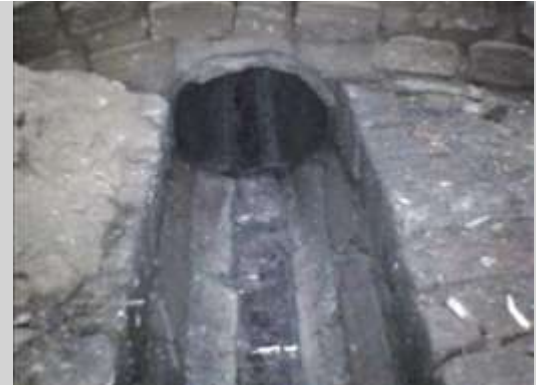
6 O'Clock Inflow

Infiltration: **None** Pipe Seal Cond: **Cracked**

Drop: **Outside** Rod and Bar
Angled: **Yes** Reading: **9.90** (ft.)
Inv Depth: **10.90** (ft.)
Drop Condition: **Open**
